Air Quality Analysis of Merrimack College

Joseph McKeown
CEN 5030 - Environmental Design
Dr. Cynthia Carlson
12/9/19

Air Quality Analysis of Merrimack College - Honors Contract

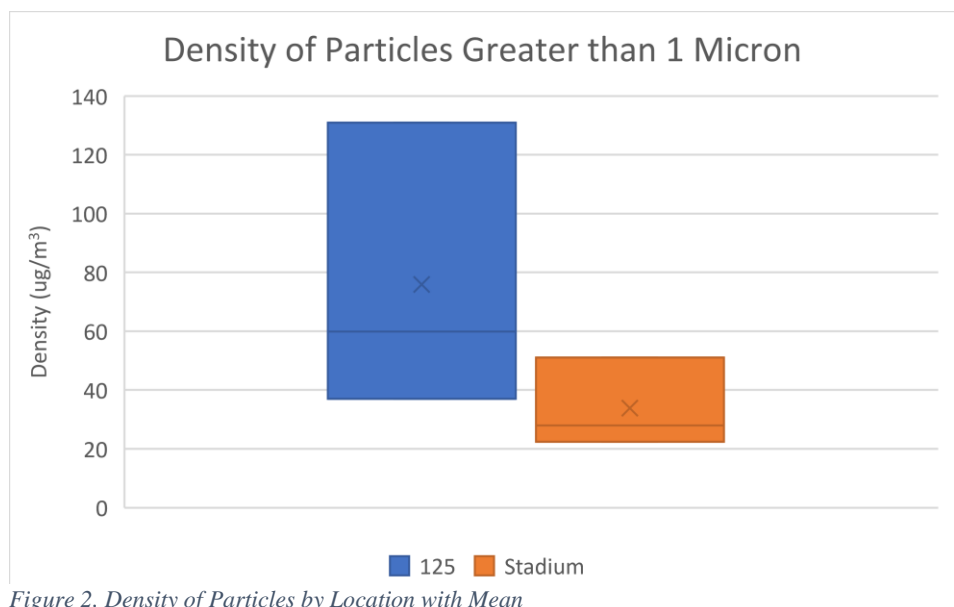
Figure 2. Density of Particles by Location with Mean

After seventeen samples were taken, only six data points ended up with a normal result. Luckily, those six consisted of three from each site. The average density from the Route 125 location was 75.9 ug/m³ while the average density of the back of campus was 33.7 ug/m³. These results show a considerable difference due to the location from campus. However, since the amount of data points are so small, it should be replicated in order to determine its accuracy. The Route 125 data is less accurate and has a standard deviation that

is so big that it includes the average of the back of campus.
