Air Quality Analysis of Merrimack College

Joseph McKeown
CEN 5030 - Environmental Design
Dr. Cynthia Carlson
12/9/19

Air Quality Analysis of Merrimack College - Honors Contract

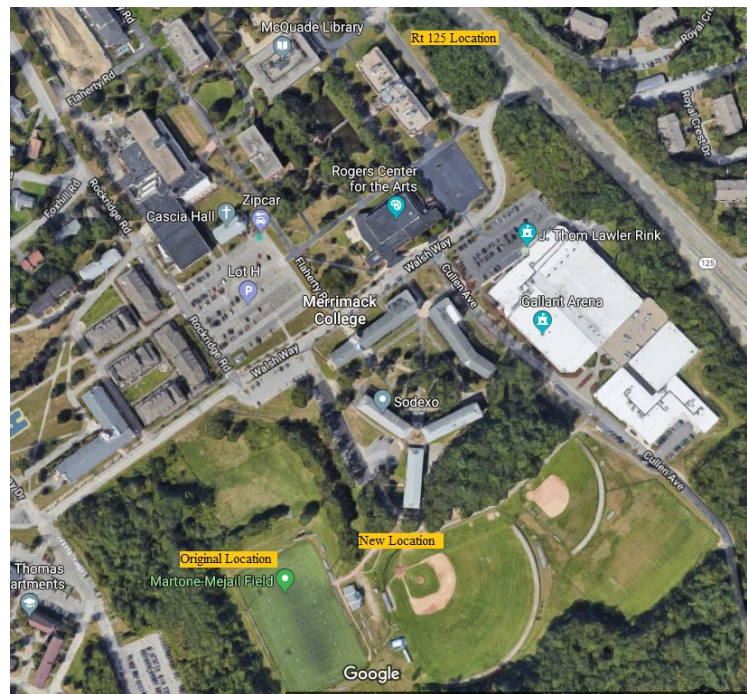
Figure 1. Location of Testing Sites

The first location to be tested is by Massachusetts State Route 125. This location sees thousands of cars a day due to its radial approach to Boston. Many people commute by Merrimack College. This location was selected because it borders Merrimack College on the east side and many students walk by or across to Royal Crest Apartments. The air surrounding this road would constantly be breathed by students and faculty. There are also several power points due to the light poles along the sidewalk. Since this location is near Mendel Hall, this enables the air testing while performing other collegiate duties within a sight distance.

The other location to be tested is towards the back of campus away from the main roads. This location was difficult to determine due to the limited power points in the back of the campus. Originally, the location was intended to be by the pedestrian bridge that connected Lot K to Martone-Mejail Field. However, due to

the lack of power outlets, the location needed to be moved the entrance to Martone field. There is a problem with this because it is close to Lot M, which is the gravel lot used by commuters. However, since not as many cars travel this area compared to Route 125, the data should still be lower.

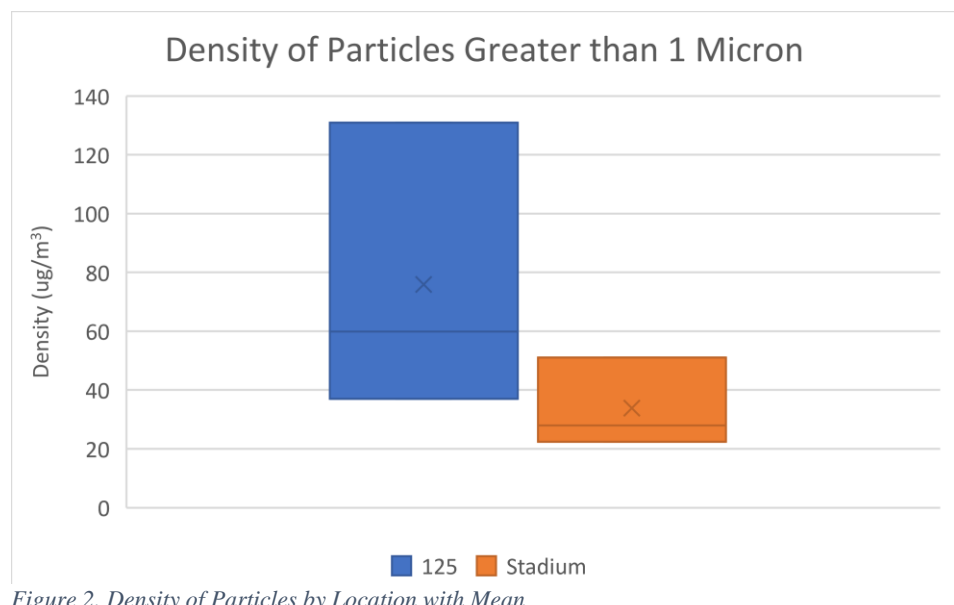
Figure 2. Density of Particles by Location with Mean

After seventeen samples were taken, only six data points ended up with a normal result. Luckily, those six consisted of three from each site. The average density from the Route 125 location was $75.9 \mu\text{g}/\text{m}^3$ while the average density of the back of campus was $33.7 \mu\text{g}/\text{m}^3$. These results show a considerable difference due to the location from campus. However, since the amount of data points are so small, it should be replicated in order to determine its accuracy. The Route 125 data is less accurate and has a standard deviation that

is so big that it includes the average of the back of campus.

If this data is accurate enough to represent all of the air around campus, then it would be healthier for students to breathe air away from the major roads. As mentioned earlier, the maximum desired density of particles with a diameter of 10 microns is $150 \mu\text{g}/\text{m}^3$. Since all of our data is below this number, the campus is safe according to the EPA. However, the maximum density for particles of a diameter of 2.5 is $35 \mu\text{g}/\text{m}^3$. We cannot directly assume that all of the route 125 data points are above this value because this number contains particles that are over that diameter size. Another test with a filter that only traps 10 microns and above would be needed to be subtracted from the values found in this test in order to determine the particles that have a diameter of 2.5. However, it does show that there are more particles in the air closer to roads and buildings compared to fields.
